**FOREST LAKE DAM**

**NDI ID NO. PA-00968**

**PHASE I INSPECTION REPORT  
NATIONAL DAM INSPECTION PROGRAM**

**MAY 1981**

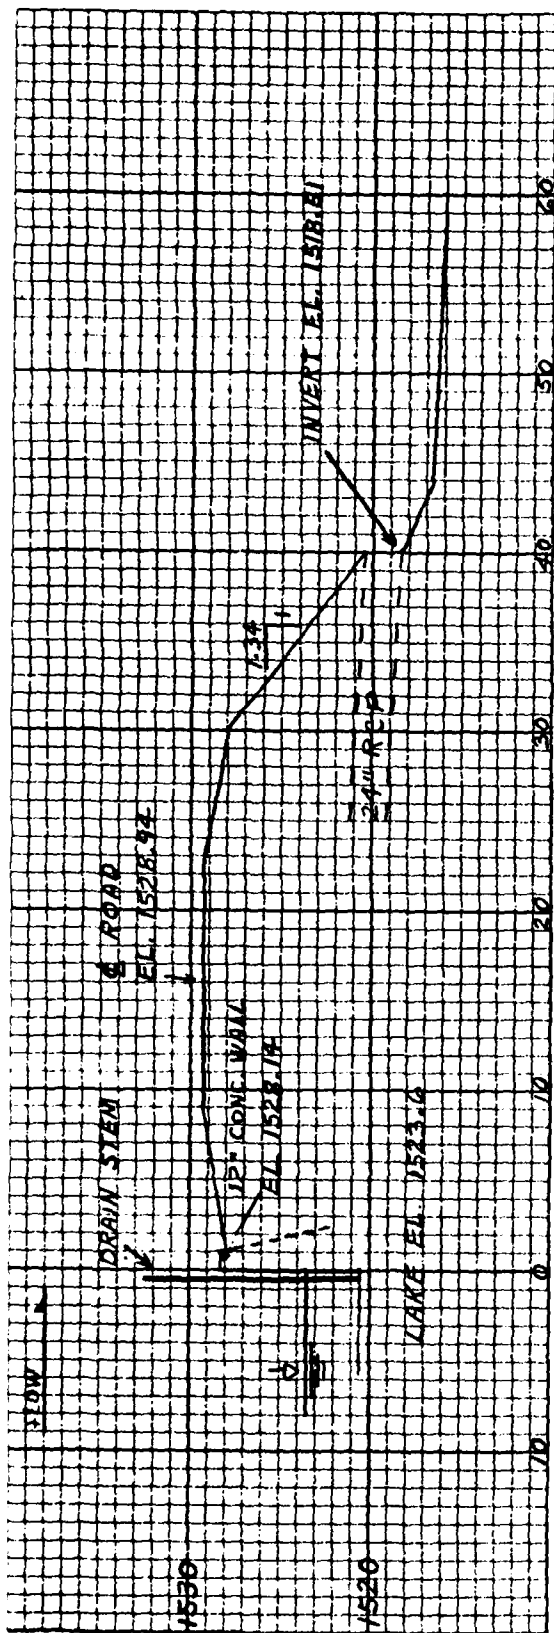
# OUTLET WORKS

The outlet works is located near the maximum section of the dam, approximately 80 feet east of the right abutment. On the day of the inspection, the water surface in the reservoir was above the intake and its condition could not be verified. Available data indicates the existence of a trash rack at the inlet to the 24-inch diameter concrete pipe. The slide gate is operable by means of a stem, located near the middle of the concrete headwall (see Exhibits A-1 and A-4).

The outlet works concrete headwall retains the adjacent upstream earth-fill section of the dam. The top two foot section of this wall is tilted toward the reservoir. The observed 5 degree tilt from the vertical is above a horizontal construction joint, extending along the entire length of the wall. Information relative to wall reinforcement is inadequate to assess the stability of the tilted portion of the wall against overturning. Failure of the tilted wall section would bend the stem and cause damage to the slide gate. Additionally, failure of this wall will be hazardous to the roadway traffic over the dam.
